NZ 60

Apia

29 July 2000

“A FREE LESSON”

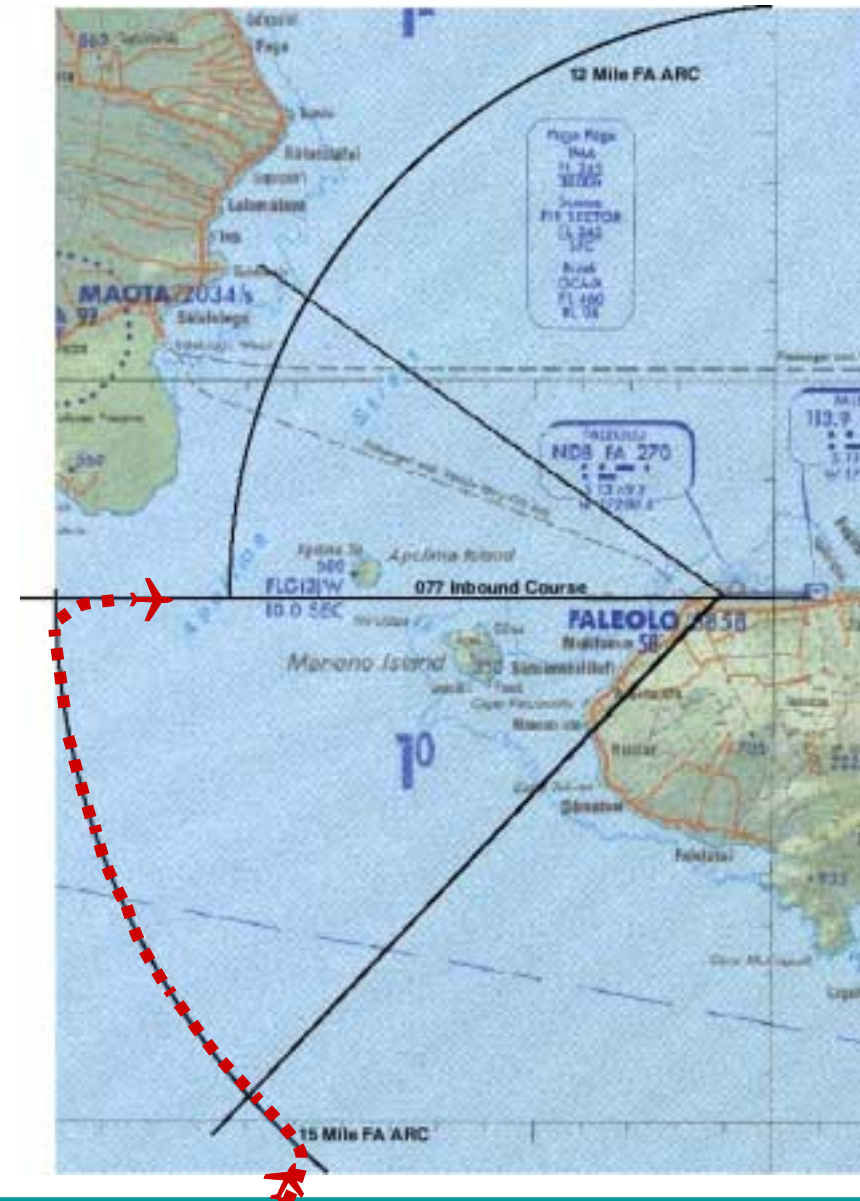
The Localizer 077° inbound course was captured at 14 miles, Flap 1 was selected, speed 220 KIAS

One second after APPROACH was armed the autoflight system captured the glideslope

Approximately 5 seconds after glideslope capture the rate of descent increased
