On 1 June 2006 a Beechcraft Bonanza was on final approach to Bathurst Island, NT, at approximately 0845 CST, in VMC conditions, the aircraft sustained loss of engine power and crashed into bush land, approximately 1.2 km to the north-west of the Bathurst Island runway. The pilot was fatally injured.

The presentation will cover aspects of the accident investigation, paying particular attention to the recovery of data from a new type of engine indicating and recording instrument with a non-volatile memory.

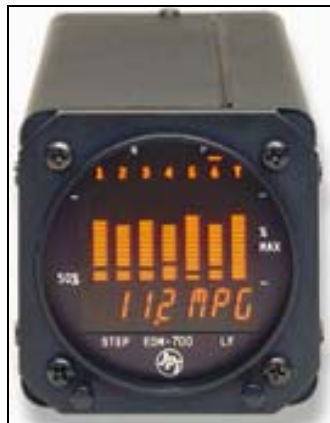
Figure 27: EDM 700

An Engine Data Management instrument, the EDM 700 was found fitted to the aircraft. The instrument is predominantly an engine indicating device, it indicates the following parameters:

- Exhaust gas temperature from all cylinders in Fahrenheit (EGT)
- Cylinder head temperature from all cylinders in Fahrenheit (CHT)
- Differential EGT in Fahrenheit (DIF)
- Rapid cooling of cylinders in Fahrenheit (CLD)
- Fuel flow in gallons per hour (FF)
- Fuel used in gallons (USD)
- Battery bus voltage (BAT)

The EDM 700 has a non-volatile long term memory for engine trend monitoring purposes. If the instrument is set to record, it will store all the information displayed once every six seconds or at a programmed interval between two to five hundred seconds.

The typical amount of data stored is 20 engine operating hours at 6 second intervals. When the memory becomes full, the oldest data will be discarded to make room for the newest data.

When the engine is started and the EGT reaches 500 degrees F, the instrument starts recording, the recordings are separated by engine start and stop sequences, each engine start and stop sequence is given a flight number, flight time and date, each six second recording is time stamped in Universal time co-ordinated (UTC).

The recorded data can be downloaded using manufacturer software and a standard computer. The instrument stops recording when the battery bus voltage falls below 11 volts DC, the radio master is switched off, or the electric power supply is cut.

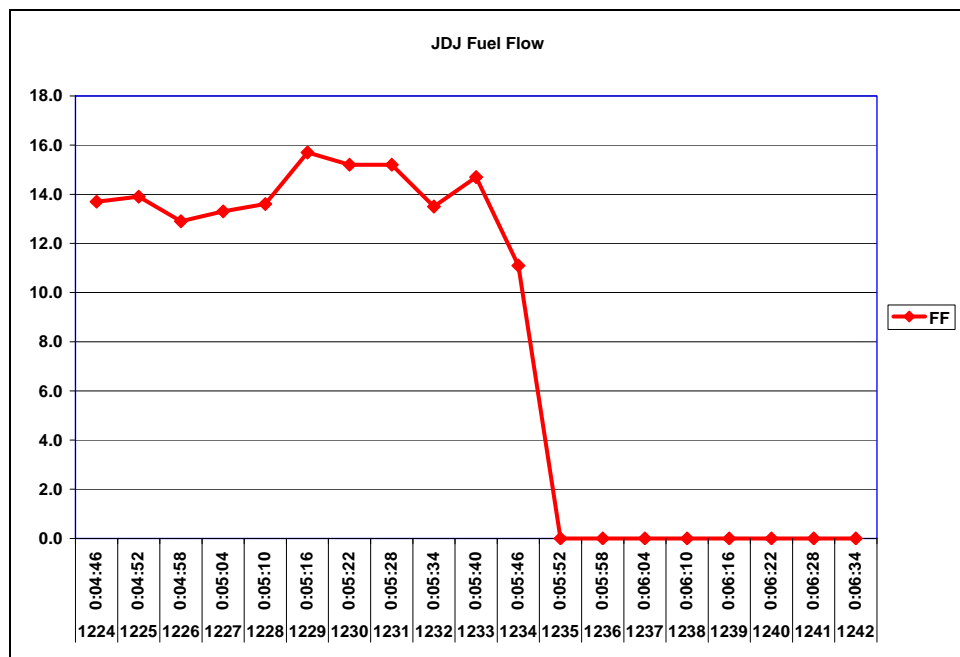
Figure 30: Fuel flow graph for the last 84 seconds of flight

Figure 30 is a fuel flow graph of the last 114 seconds of flight. The last 48 seconds shows a clear drop in fuel flow to zero.

Figure 29 shows the last 114 seconds of raw data from the accident flight. Analysis of the data confirmed that in the last forty eight seconds of flight there was a zero fuel flow indication (highlighted in red) with a corresponding drop in EGT and CHT indications (highlighted in blue), this is consistent with a fuel starvation event taking place.

Although there was zero indicated fuel flow in the last 48 seconds of flight, the engine was still turning. This is indicated in the data, by battery voltage remaining constant (refer to figure 29, the green column titled BAT).

If the engine had completely stopped, the alternator would have stopped turning, this would have caused a corresponding drop in indicated voltage from the battery bus, from 28.2 volts DC to a maximum of 24 volts DC, which is the maximum discharge voltage of the battery.

The propeller may have continued turning because it was windmilling or perhaps the engine was receiving just enough fuel to keep the engine running at a severely reduced rate.

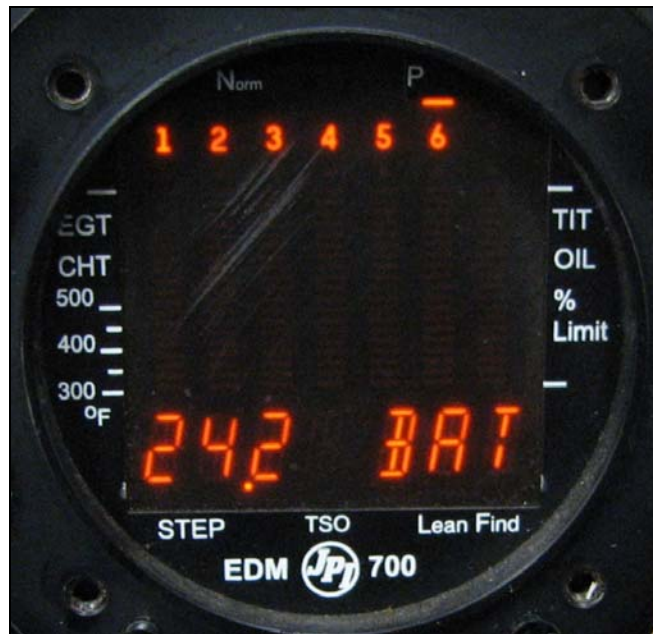
Figure 31: EDM 700 indicating battery voltage

Figure 31 shows the EDM 700 connected to a DC power supply, the power supply output voltage was 24.2 as indicated on the instrument. This shows that the instrument was indicating the correct voltage.
