NZ 60

Apia

29 July 2000

“A FREE LESSON”

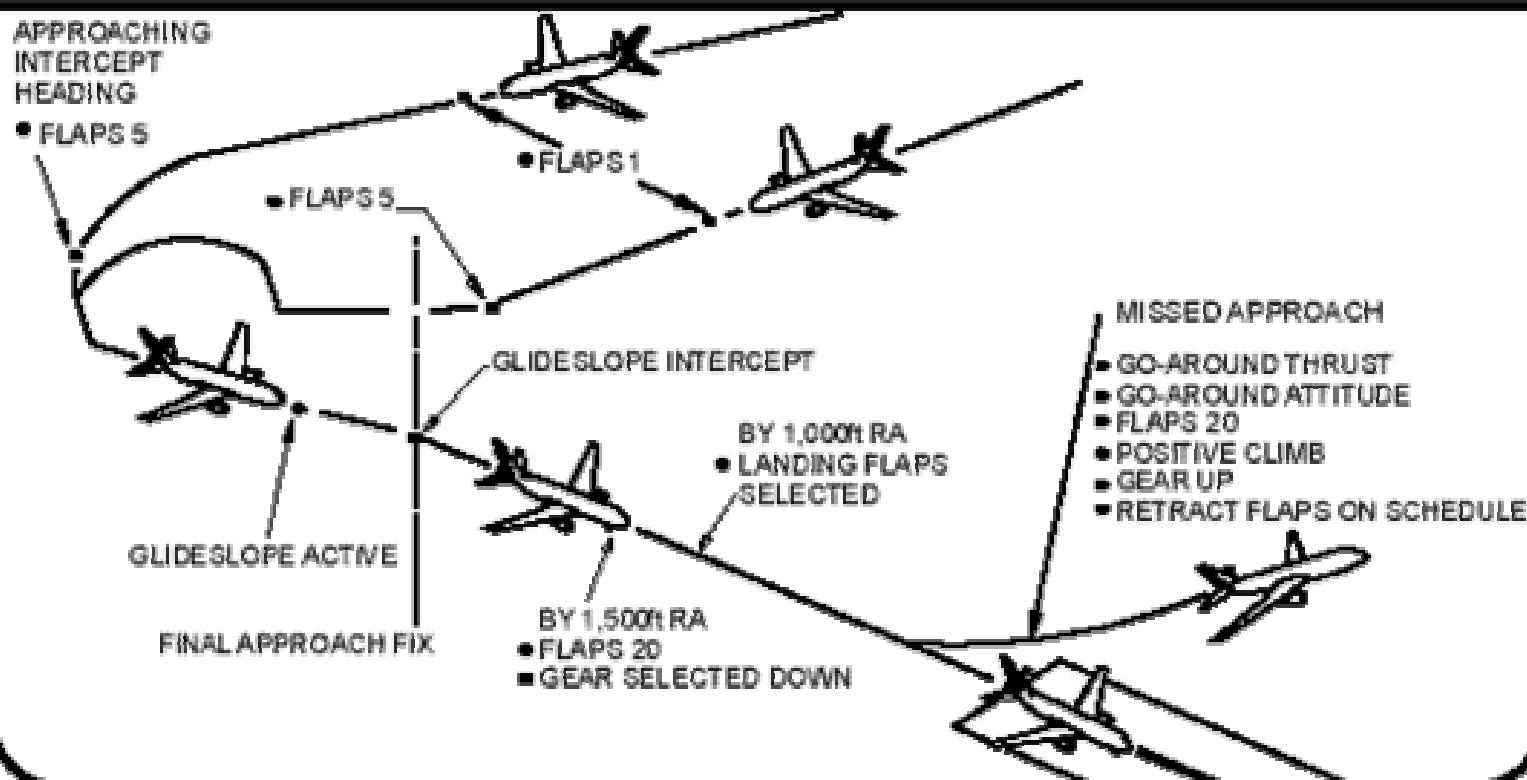
Low Drag Approach Profile

LOW DRAG APPROACH (Refer SOP 2.6)

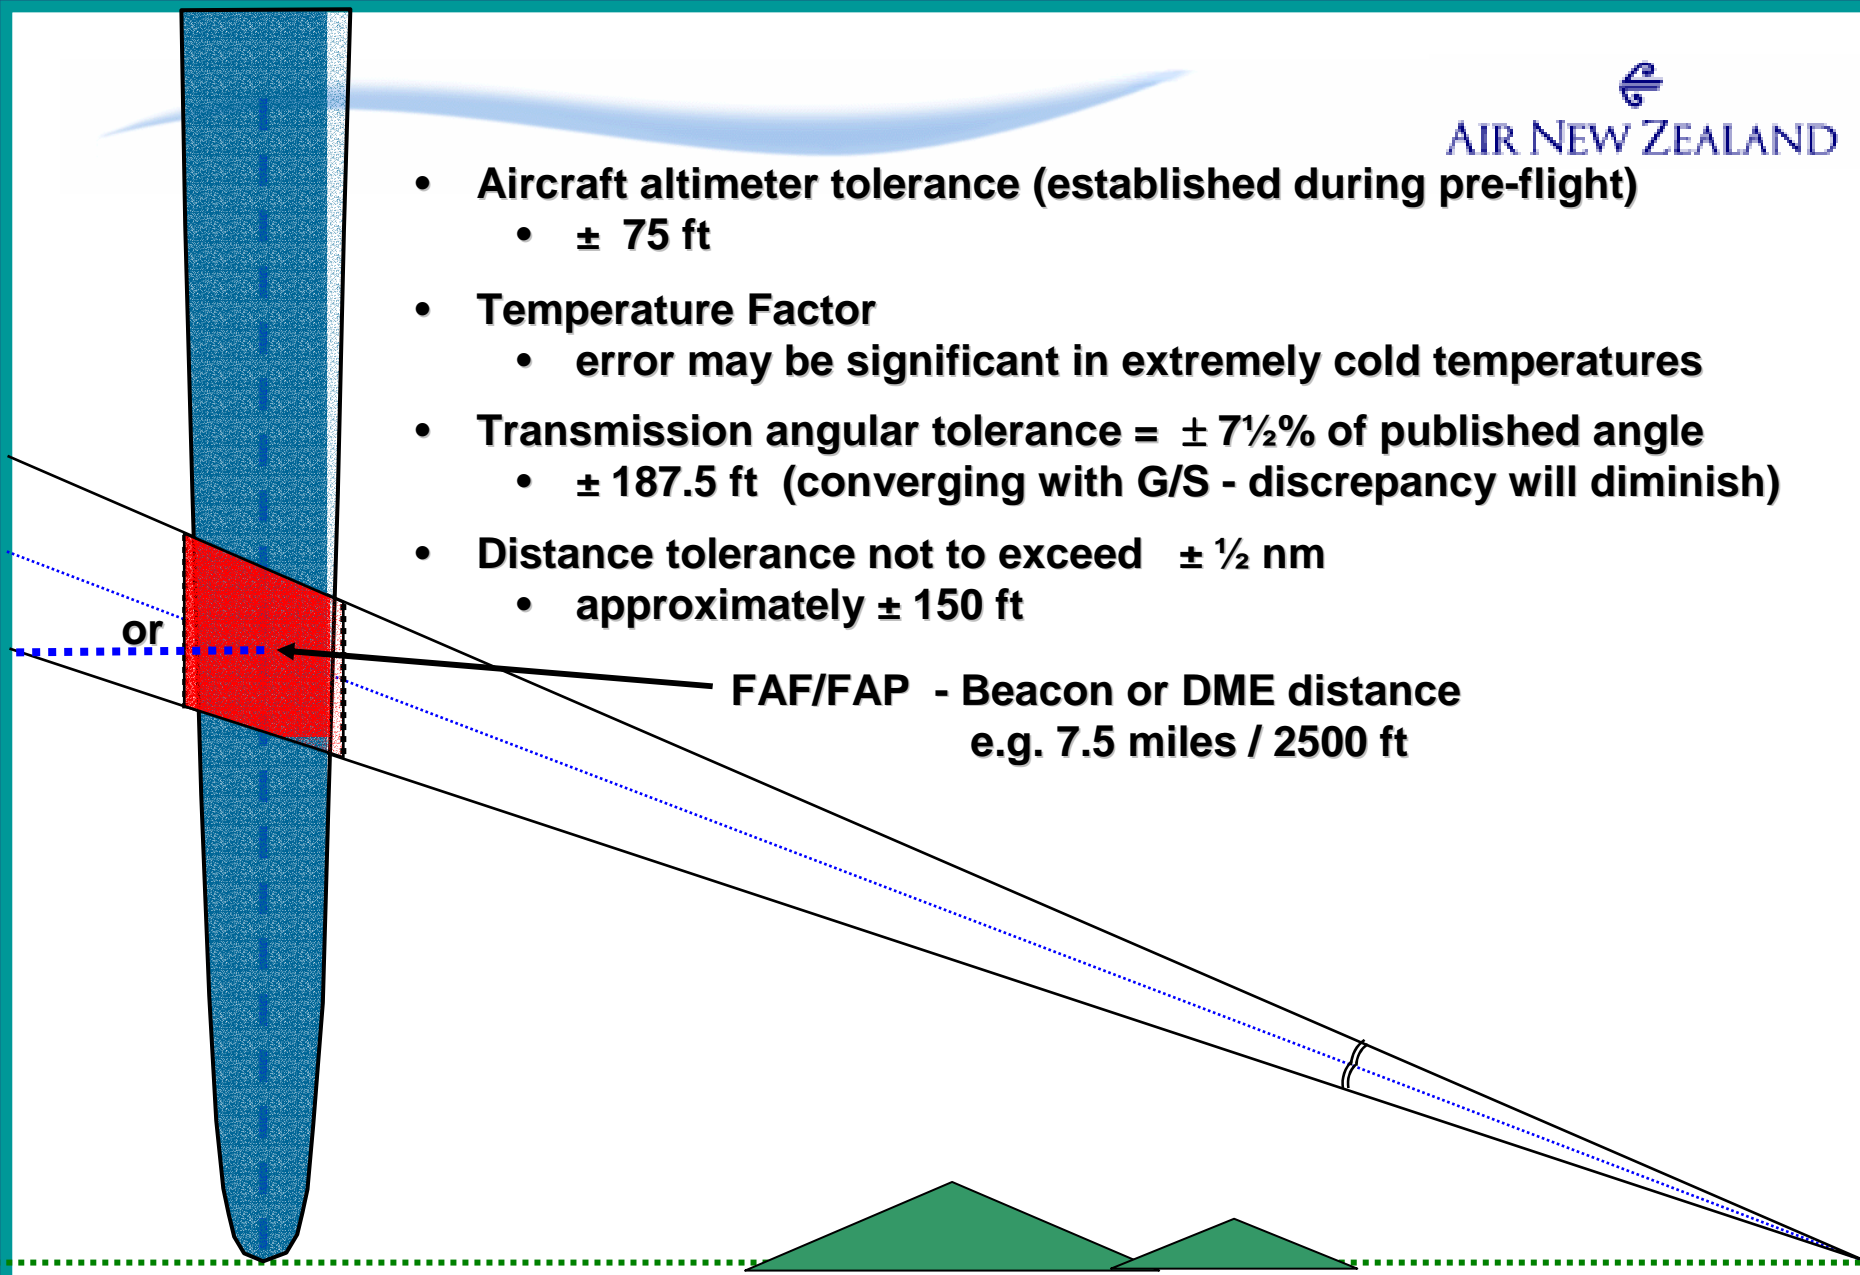
- Aircraft altimeter tolerance (established during pre-flight)
 - ± 75 ft
- Temperature Factor
 - error may be significant in extremely cold temperatures
- Transmission angular tolerance = $\pm 7\frac{1}{2}\%$ of published angle
 - ± 187.5 ft (converging with G/S - discrepancy will diminish)
- Distance tolerance not to exceed $\pm \frac{1}{2}$ nm
 - approximately ± 150 ft

FAF/FAP - Beacon or DME distance
e.g. 7.5 miles / 2500 ft

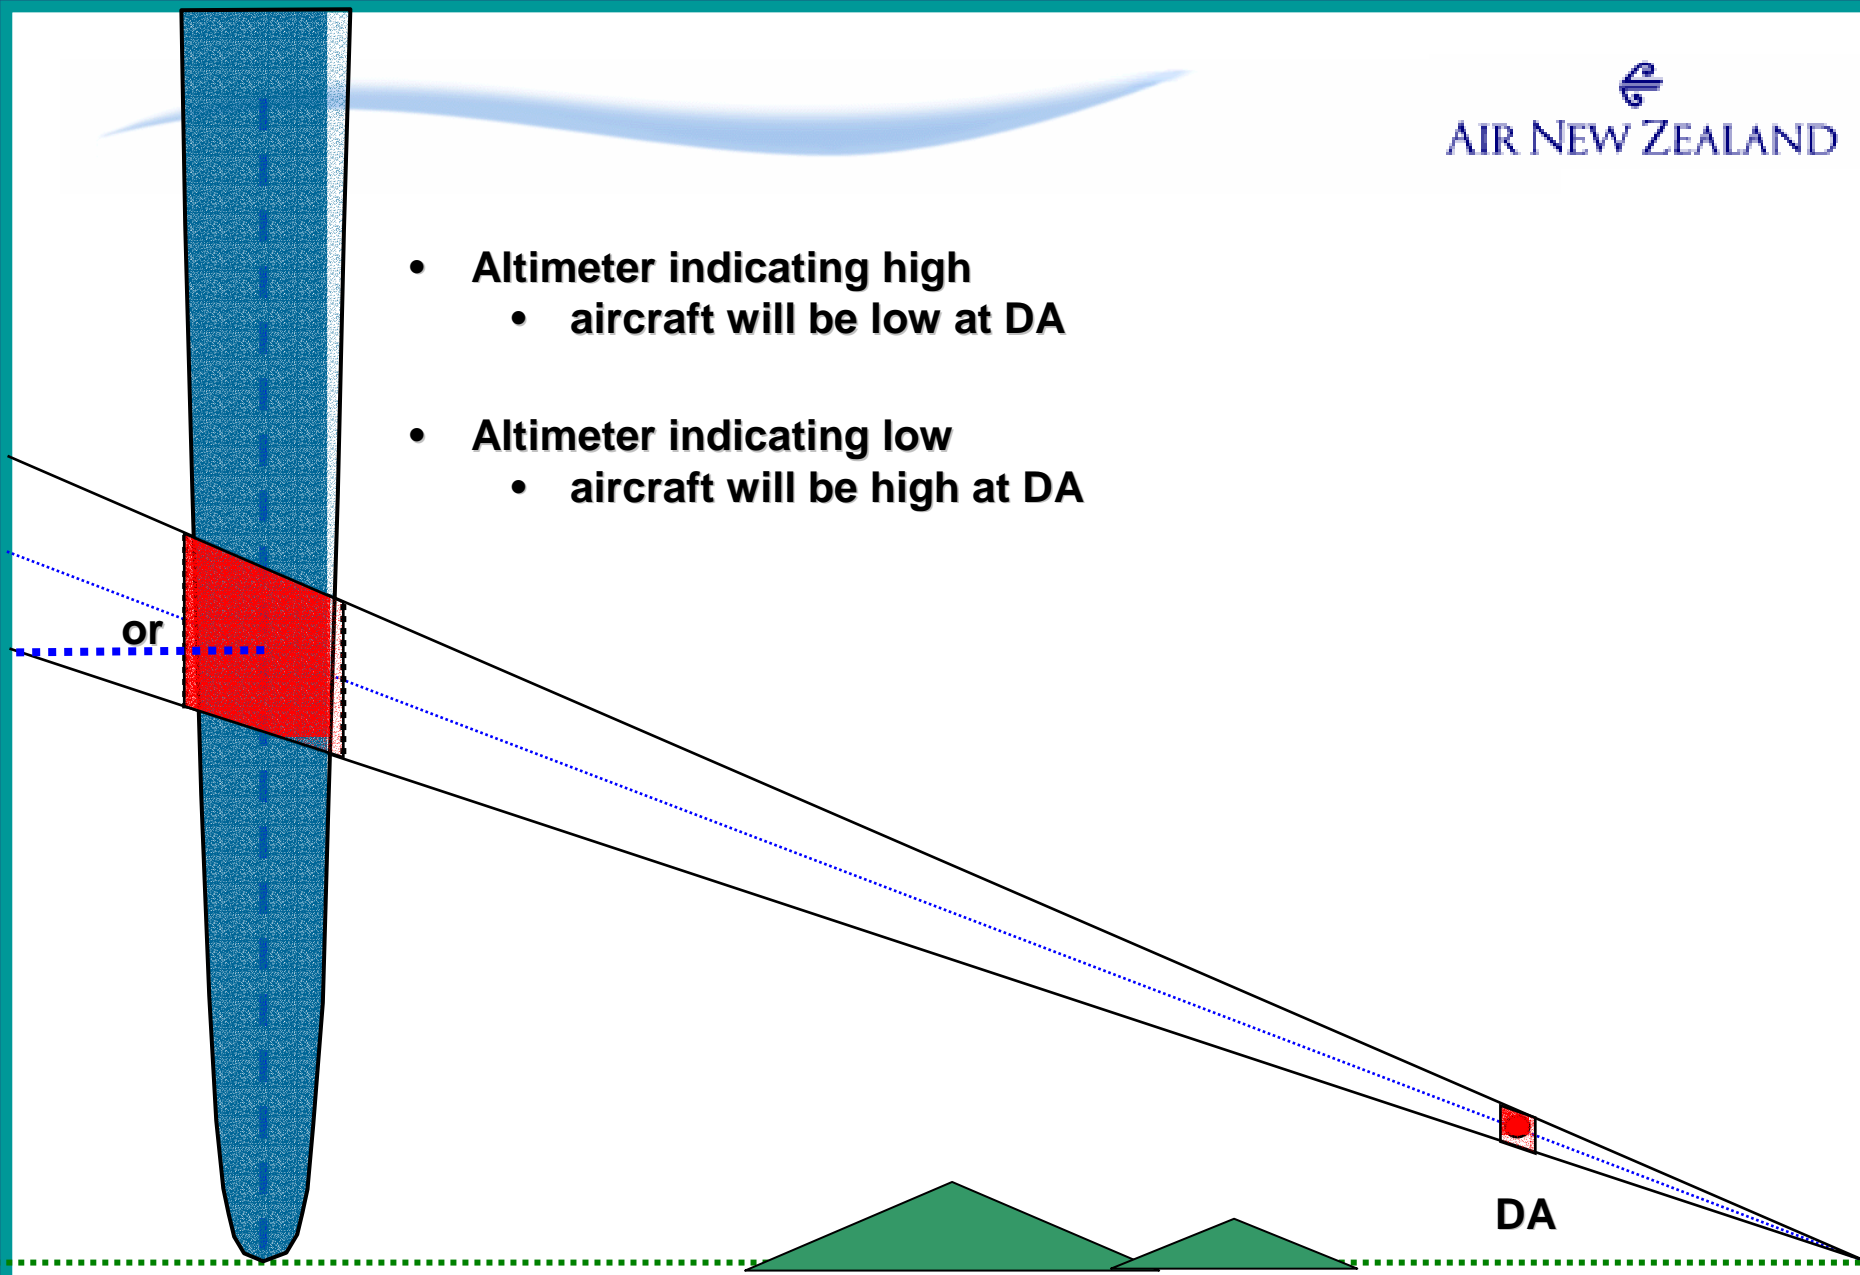
- Altimeter indicating high
 - aircraft will be low at DA
- Altimeter indicating low
 - aircraft will be high at DA
